Humboldt Bay and Eel River Eelgrass Monitoring and Pilot Study Project (2020-2023)

Prepared for:
**California Sea Grant
And NOAA Fisheries**

Whelan Gilkerson, Senior Biologist & GIS Analyst
Keith Merkel, Principal Ecologist
Merkel & Associates, Inc.
Arcata, CA

June 2023

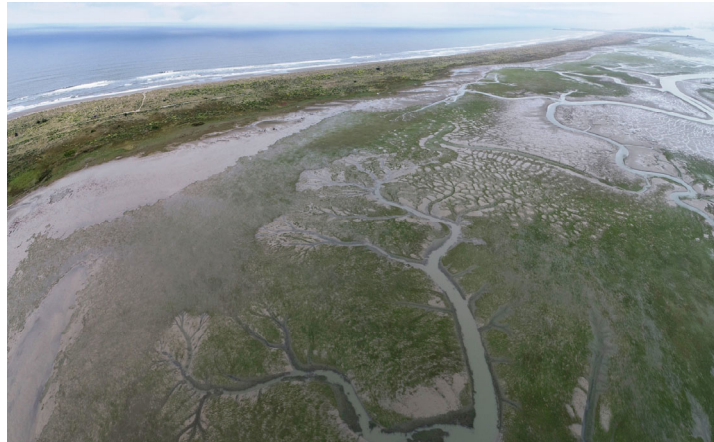
Oblique view facing northwest of the pilot study site in South Humboldt Bay, CA (foreground) where eelgrass losses have been occurring and Pacific Ocean (background).

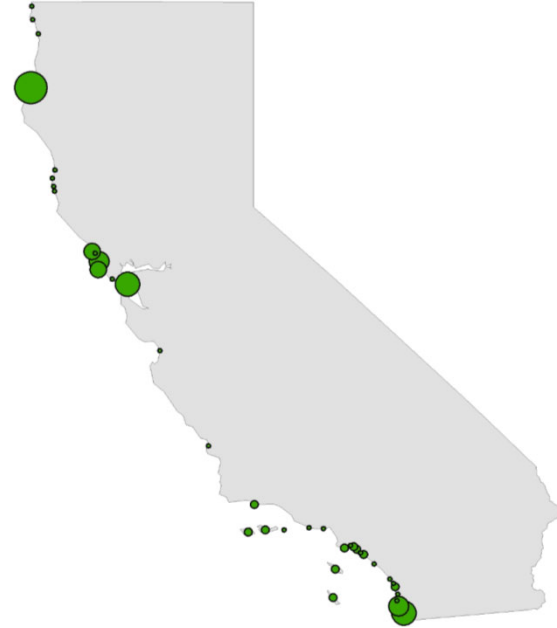
General distribution of eelgrass in California with the relative extent of eelgrass in each system indicated by size of location marker. Systems with less than one acre of eelgrass are not shown. (Merkel & Associates unpublished data)

The results of the 2009 benthic habitat mapping confirmed that Humboldt Bay contains the most extensive eelgrass beds in California, representing approximately 35% of the state's eelgrass resources by area (Merkel & Associates 2017), and has one of the largest concentrations of eelgrass habitat on the entire West Coast, providing critical ecosystem functions at the local, regional, and coast-wide scales.

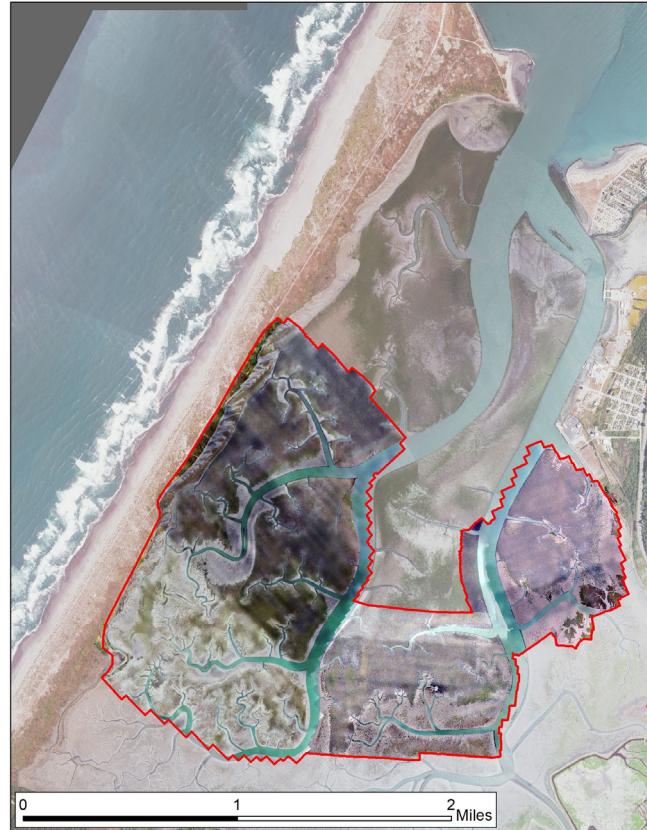
Combined UAV-based orthoimagery coverage of the Task 1 study area in South Humboldt Bay flown between June 2020 and July 2022.

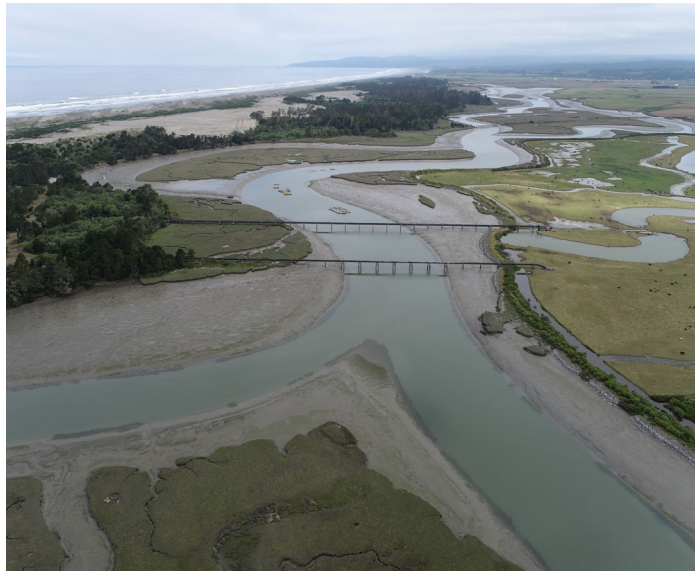
Oblique view of Mad River Slough facing north on June 29, 2021.

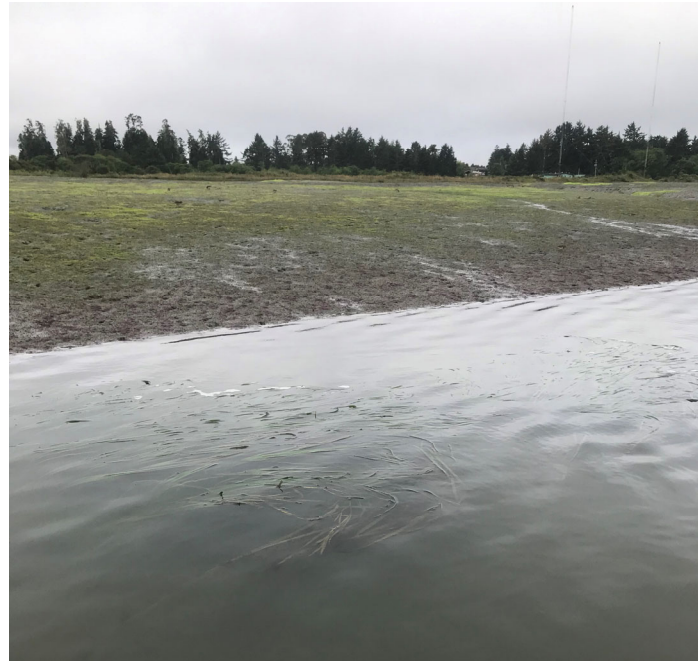
Eelgrass observed along the left bank of Eureka Slough during completion of ground truthing efforts on July 11, 2021.

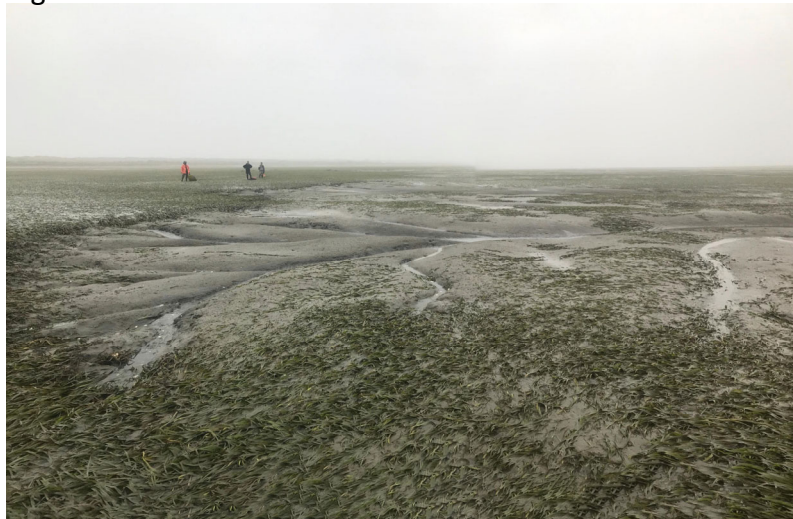
Sea Grant and CDFW staff observing an area of active headcutting, associated headward channel erosion, and eelgrass loss at the South Bay pilot site on June 5, 2020.

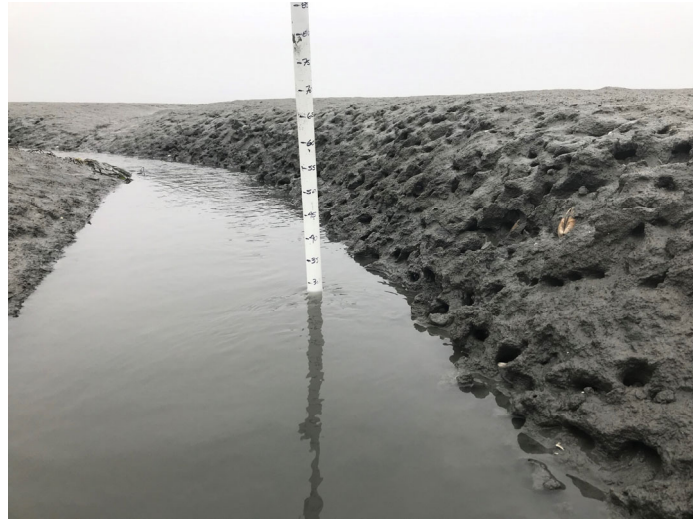
Residual depth in this newly-formed channel was assessed with a graduated stadia rod and RTK-GPS unit to survey shallow subtidal areas of the South Bay pilot site that remained inundated at low tide and could not be assessed using a UAV-based photogrammetric approach. In this photo captured on July 26, 2021, residual channel depth was found to be 27 cm with a total depth of 65 cm relative to surrounding intertidal flats.

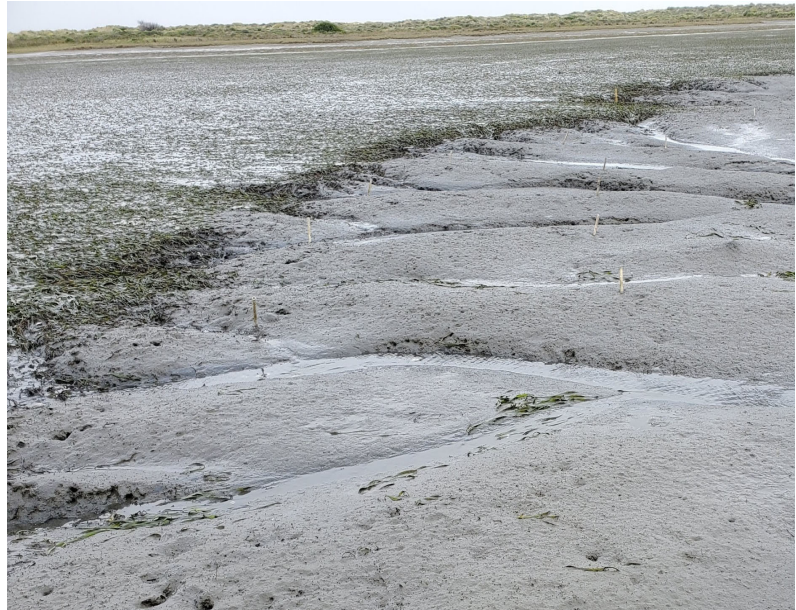
Sediment stakes at the South Bay pilot study site approximately one year after installation illustrating westward expansion of the erosional front beyond the array on June 27, 2021.

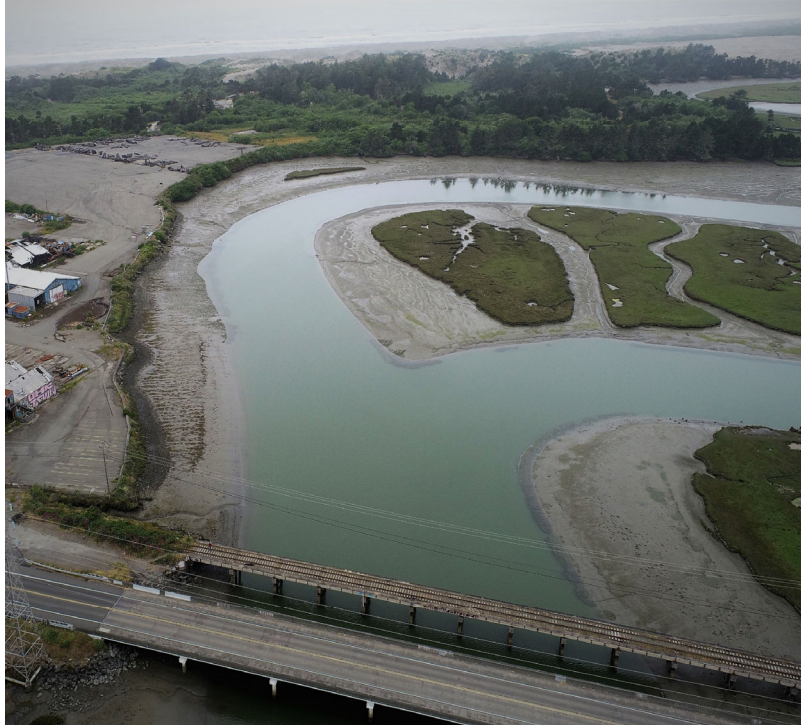
Oblique aerial view of lower Mad River Slough facing northwest, captured on June 29, 2021. The pilot study site is visible on the western bank of the slough (left) immediately north of the bridge where the lighter coloration of the lower portion of the exposed bank illustrates the area subject to recent erosion and eelgrass bed retreat at the site.

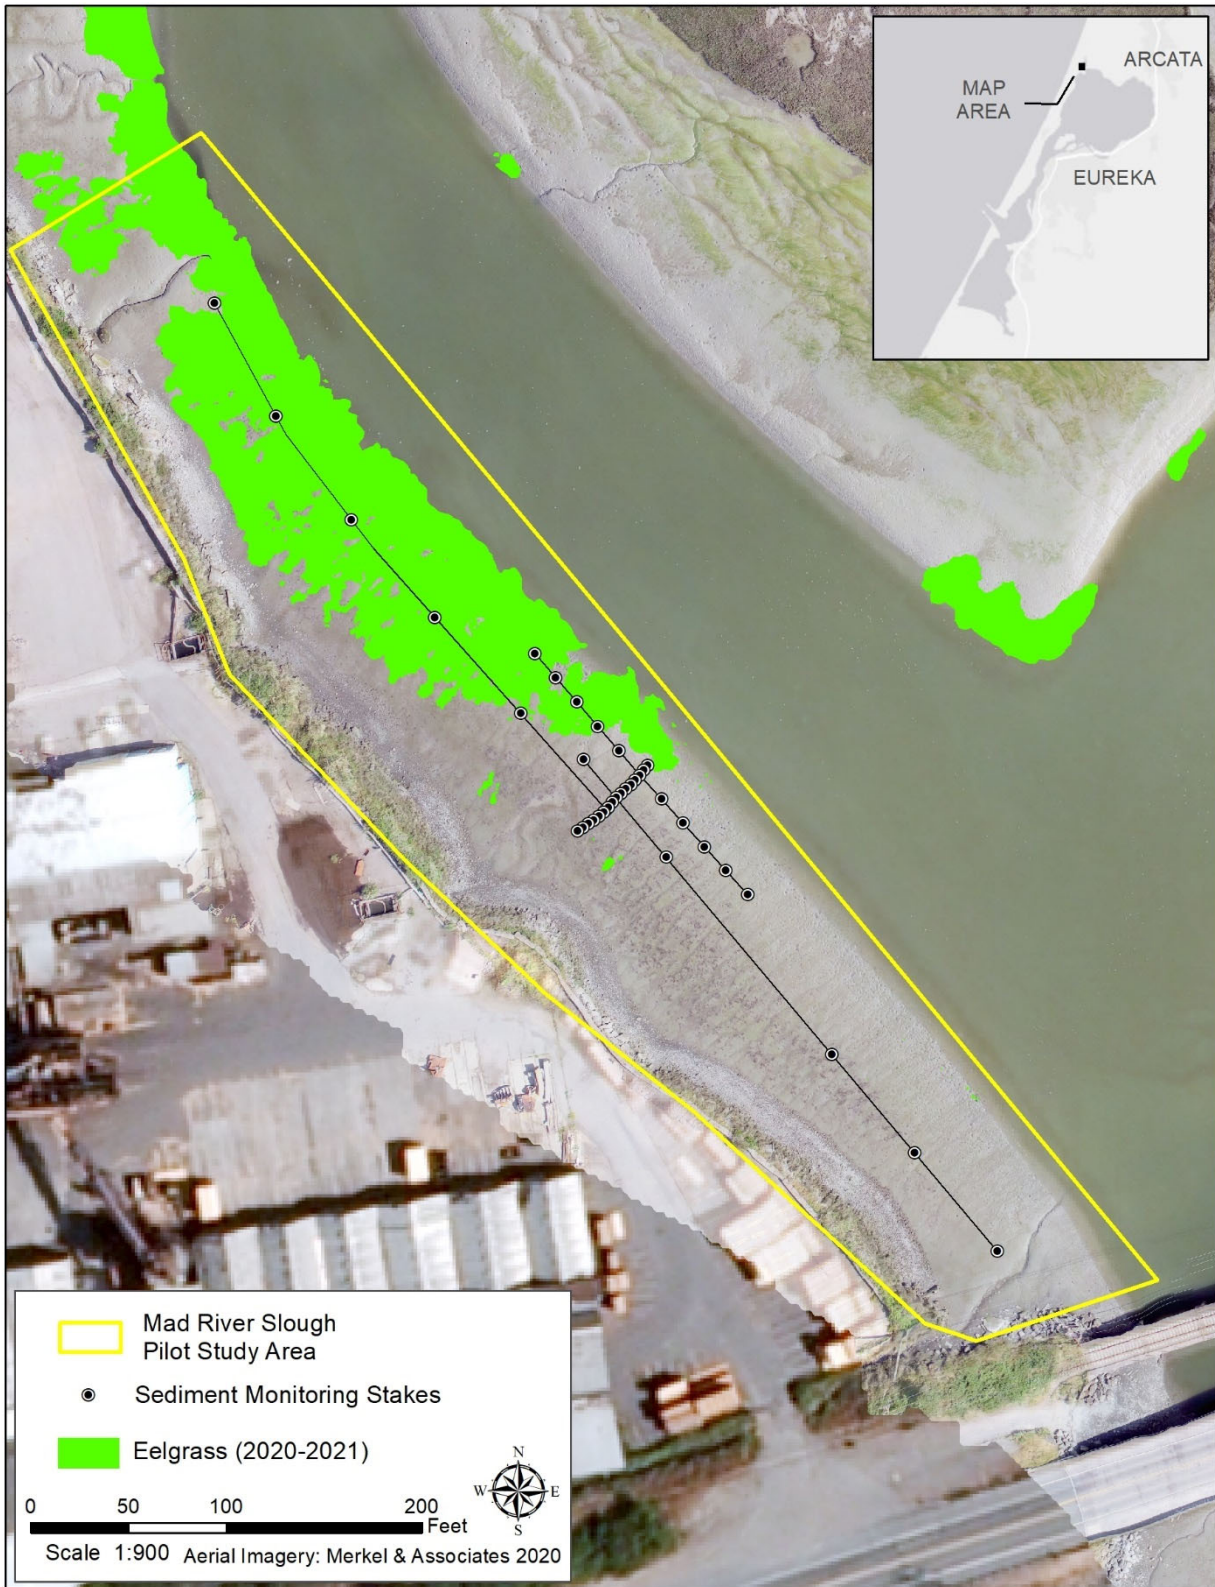
Figure 3. Mad River Slough Pilot Study Area and Sediment Stake Monitoring Arrays in North Humboldt Bay.

At the Mad River Slough pilot site, PVC stakes were positioned in three linear arrays along the right bank of the slough beginning immediately north of the bridge where eelgrass bed retreat was observed in May 2020 prior to the initiation of the study. The primary linear array was established coincident with the long-term eelgrass monitoring transect parallel to the slough channel near the center of the eelgrass depth distribution and was approximately 190 meters in

A third stake array was established near the center of the primary and secondary arrays perpendicular to the channel to assess changes in the channel cross-section, with sediment stakes positioned at 1-meter intervals. Sediment stakes were installed on June 8, 2020, and embedded into the substrate. Figure 3 depicts the Mad River Slough pilot study site, sediment stake monitoring arrays, and eelgrass distribution derived from the Task 2 slough surveys completed in 2020-2021.

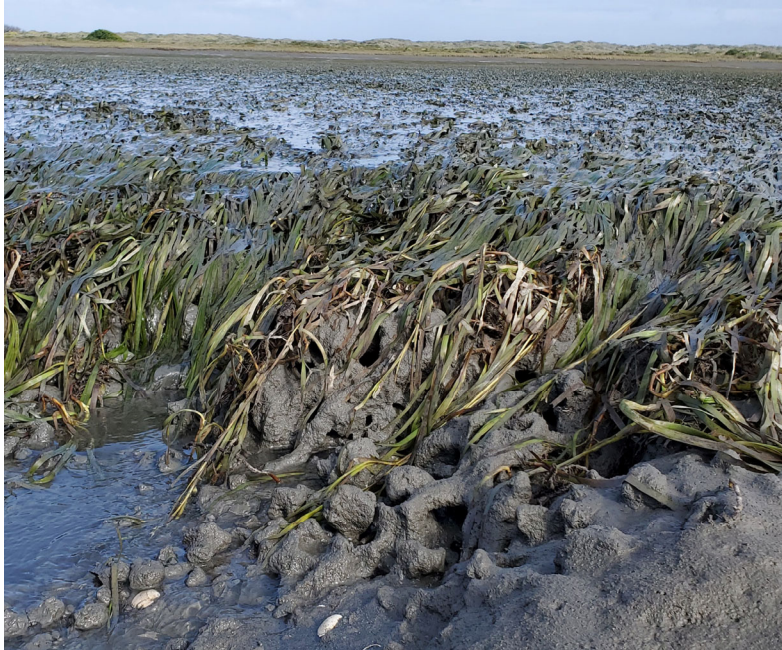
Eelgrass plants exhibiting evidence of physiological stress and wasting disease along the scarp associated with the advancing erosional front in the South Bay study area in July 2021. Cavities in the exposed substrate resulting from infaunal biogenic activity are also visible along the scarp. Photo credit: Joe Tyburczy

areas affected by erosion relative to the unaffected meadow. With respect to eelgrass wasting disease, indicative necrotic lesions and leaf shed were observed at low to moderate levels within the eelgrass meadow but were most prevalent in plants located at the advancing scarp that formed at the leading edge of the erosional front, resulting in aerial exposure and fragmentation of eelgrass rhizomes. Biogenic activity associated with burrowing organisms in the substrate was noted along the active erosional fronts and appears to have contributed to the rapid rate of erosion observed through the formation of cavities and subsurface conduits for tidal water draining out of the meadow during outgoing tides. Silt loading on eelgrass was also observed to be most prevalent on plants within or in close proximity to the area of active erosion, likely in response to ongoing sediment mobilization. In some cases, rates and patterns of erosion have been influenced by differences in sediment density, and piping effects of invertebrate burrows.

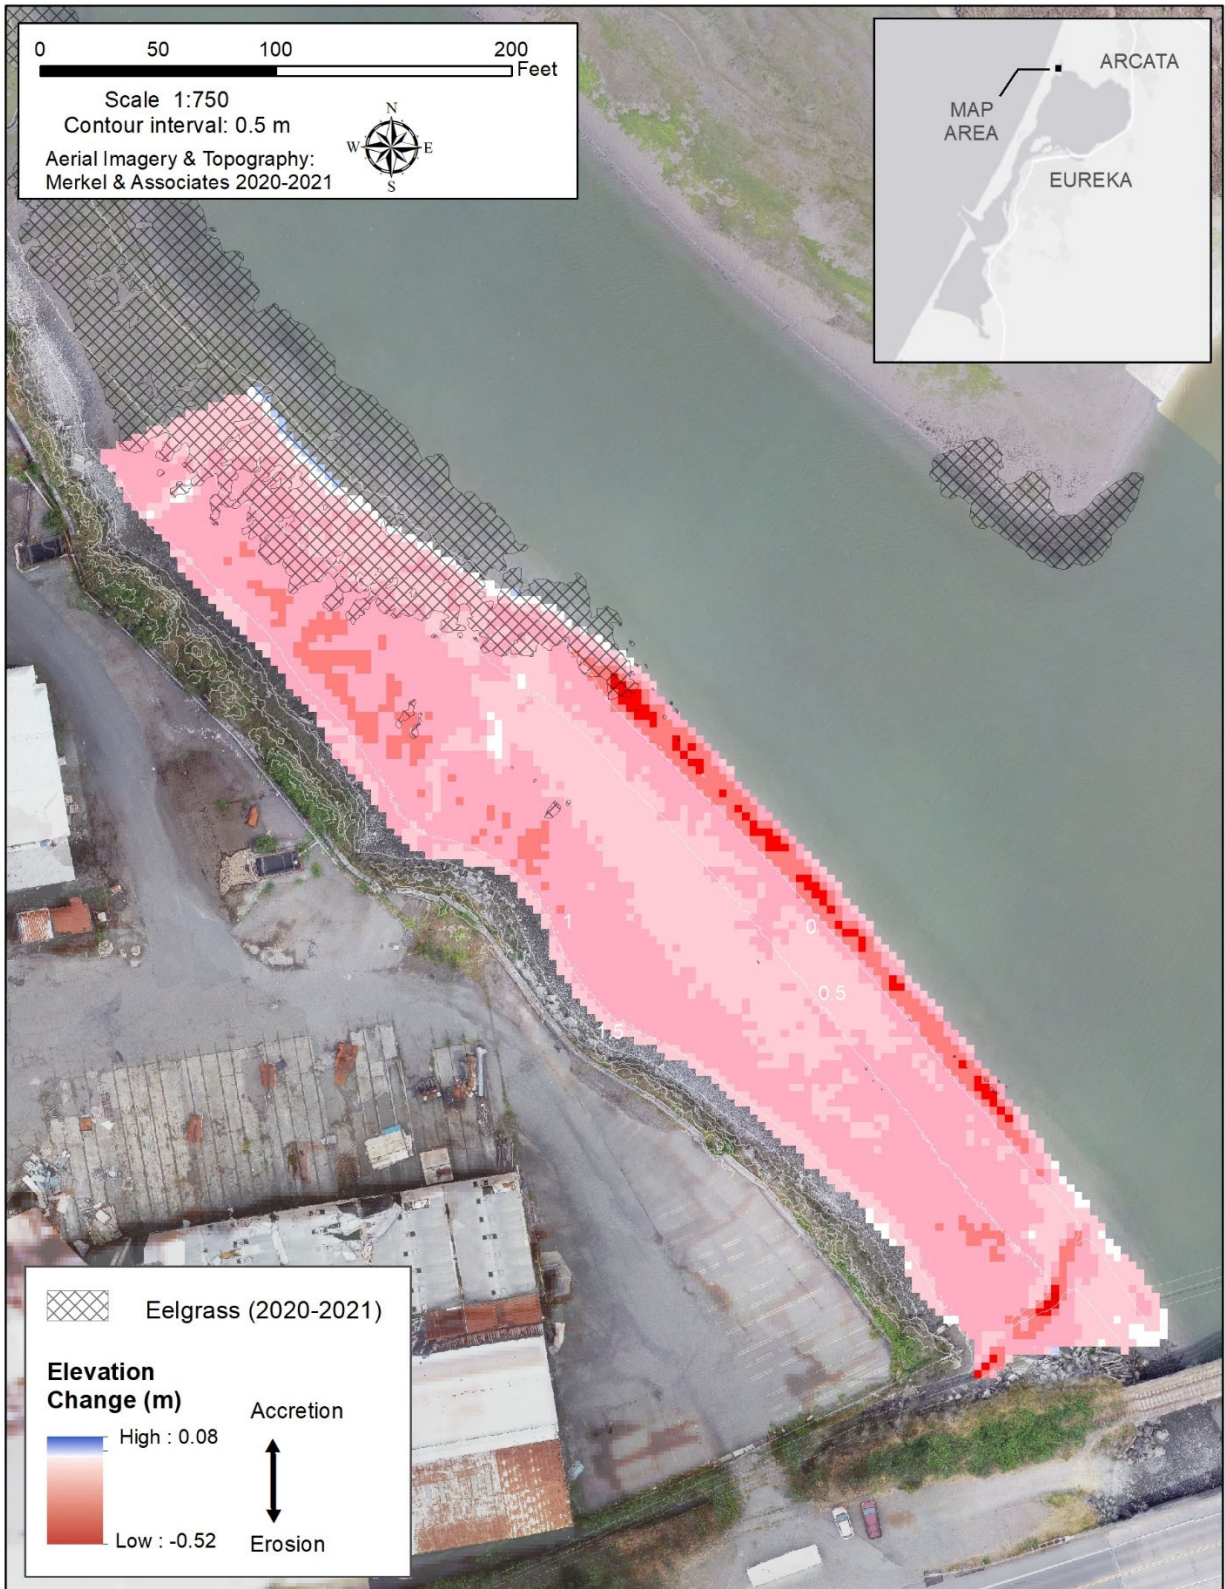
The 2021 Mad River Slough pilot study DSM was differenced against the 2009-2011 California Coastal Conservancy Lidar DEM to quantify changes since the site was last surveyed. Elevation changes ranged from an increase of 0.08 meters to a loss of 0.52 meters of elevation relative to the 2009-2011 DEM. Observed patterns of elevation change indicated that the area subject to eelgrass loss within the southern portion of the pilot study site exhibited substantial erosion in areas generally below 0.5 m MLLW, with areas of intermediate and higher elevation tending to have eroded less. In the northern portion of the pilot study area where the eelgrass bed has remained mostly intact, long-term erosion was somewhat less pronounced, with a narrow band along the lower elevation portion of the bed appearing to exhibit minor accretion. In evaluating sediment flux over the 1.2-acre portion of the pilot study site analyzed, a total of 1,045 cubic meters (1,367 cubic yards) of net sediment loss was observed between surveys.

Figure 18. Elevation Change Quantified Through Differencing of the 2021 Topobathy DSM of the Mad River Slough Pilot Study Area Developed During May-July 2021 against the 2009-2011 California Coastal Conservancy Lidar DEM.

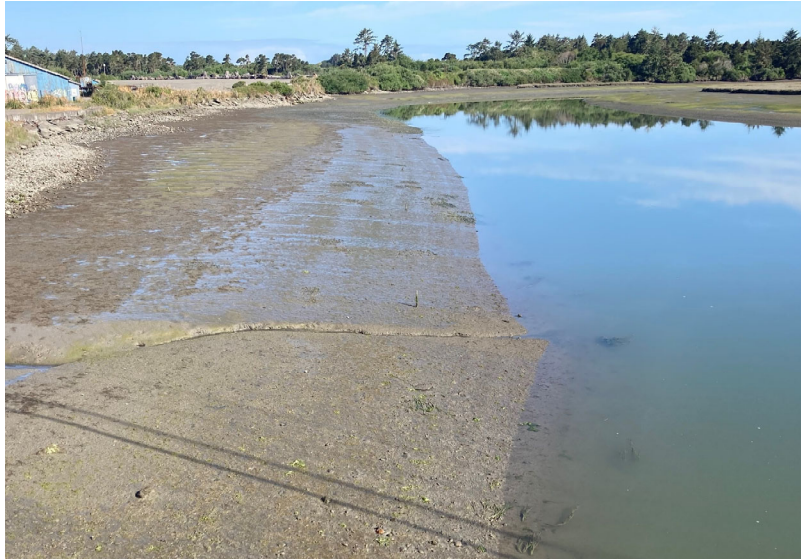
In the Mad River Slough pilot study area, early indications of eelgrass recovery were first observed in August 2022 within the area where bank erosion was most pronounced and eelgrass bed loss was observed in 2020. Virtually no eelgrass was detected within the area of bed loss in either 2020 or 2021 at this study site, but multiple yearling eelgrass plants were observed and appeared to be in good condition during the August 2022 site visit. Turion density within the newly recruited patches was approximately 50 percent lower than what was observed within the intact eelgrass bed occurring within the northern portion of the pilot study area. Eelgrass plant health otherwise appeared largely consistent between the newly recruited plants in the loss area and the bed immediately to the north, with minimal evidence of eelgrass wasting disease, low incidence of flowering, and low to moderate silt loading observed throughout the area.

Early indications of eelgrass recovery observed at the Mad River Slough pilot study site in June 2023, with several expanding eelgrass patches visible as darker areas along the lower portion of channel bank and in the water along the channel margin.
